# Blistering and Delamination of Roof Paint Coatings

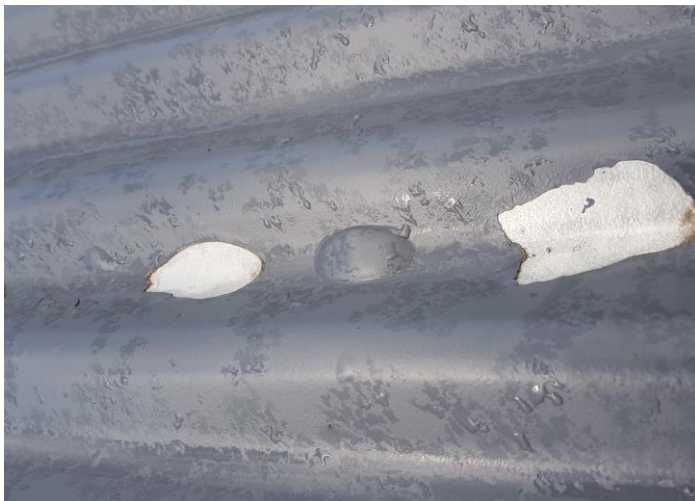
Adhesion testing of the roof coatings, carried out often right next to the blistered area, show the paint coatings are adhering to the previous paint coats. The blistering and delamination of the paint coatings is almost impossible to predict as can be seen by the adhesion testing noted.

*Photo Image - blistered roof coating showing failure at interface between original factory applied primer and roofing iron*

Remediation of this work will be extremely difficult as the affected areas will need to be entirely stripped of the paint coatings, primed and repainted. It may be cost effective to replace individual sheets of roofing iron rather than strip the paint coatings.
