Surfactant leaching on newly painted exterior surfaces

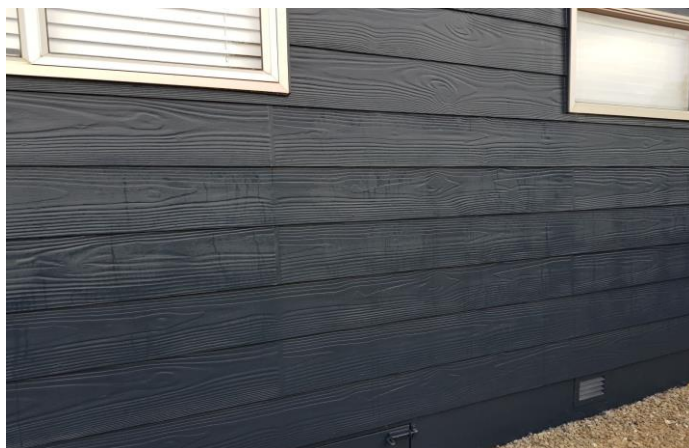
Surfactant leaching is a common occurrence with freshly applied paint coatings. The soapy deposits come to the surface of the paint coating when they are exposed to humid conditions. The leaching takes on the appearance of a clear or tannish colour stain, often running down the surface. The staining can be sticky to touch. While it can be found on freshly applied paint coatings of any colour, it is especially common on dark colours where large amounts of colourant have been used to deliver the desired colour.

This leaching is not a painting workmanship issue, and is unlikely to be happening because the painter has done something wrong or has used low quality paint.

Surfactant leaching can become noticeable after only a few days. Once the surfactant is visible it should be washed off with a soft brush and warm water before rinsing with a garden hose to remove the soap lather. The washing down may have to be done on a couple of occasions until all the surfactant is completely released.
