GHOSTING – THERMAL BRIDGING

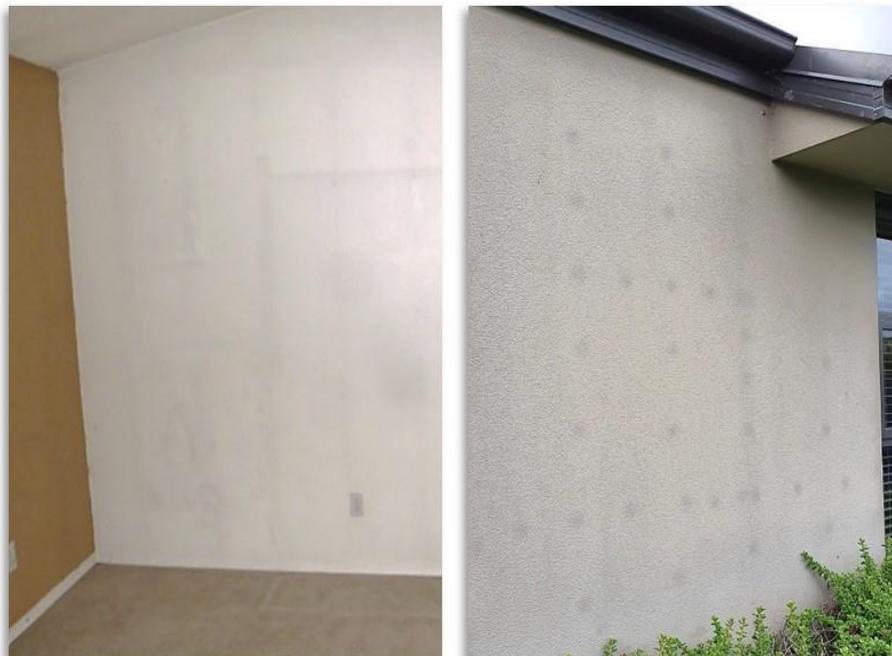
Description: Darker areas/spots showing up on the surface following the framing lines behind. Below Left photo - wall framing showing up. Below Right photo - fixing head areas showing through the polystyrene cladding.

Probable Cause/s: Ghosting (thermal bridging) is caused by either the framework, or fixings (nails/screws) being colder than the surrounding surface due to a heat sink effect. The immediate underlying area is less insulated in comparison to the area directly next to it. This can cause damp air to condense on the colder area (above frames/fixing heads) with the result being darker areas that follow the pattern of the framing. As seen below, you can notice the heads of the fixings in the polystyrene sheets under the plaster, which, because they are metal, are even colder and more prone to becoming a condensing surface. This is seen on exterior cladding just as much as interior linings. Typically, the condensation can cause more dirt to adhere to the surface, and more surface moisture, causing a colour change, thus creating irritating lines or spots on the surface.

Prevention: Follow correct building/cladding and fixing guidelines. To reduce ghosting on inside surfaces, eliminate indoor air particulates e.g., stop burning candles, coal/firewood or incense, and control relative humidity (inside) by maintaining a level of below 60 % humidity during the colder months of the year.

Remedy: If staining is developing in larger patterns, this indicates the wall, or ceiling, may not be insulated correctly, or that the fixings need to be insulated with special insulation plugs. The repair, in any case, will require that the wall or ceiling is opened up and insulated in a better way, by certified builders/plasters who understand the issue.
