GHOSTING – THERMAL BRIDGING

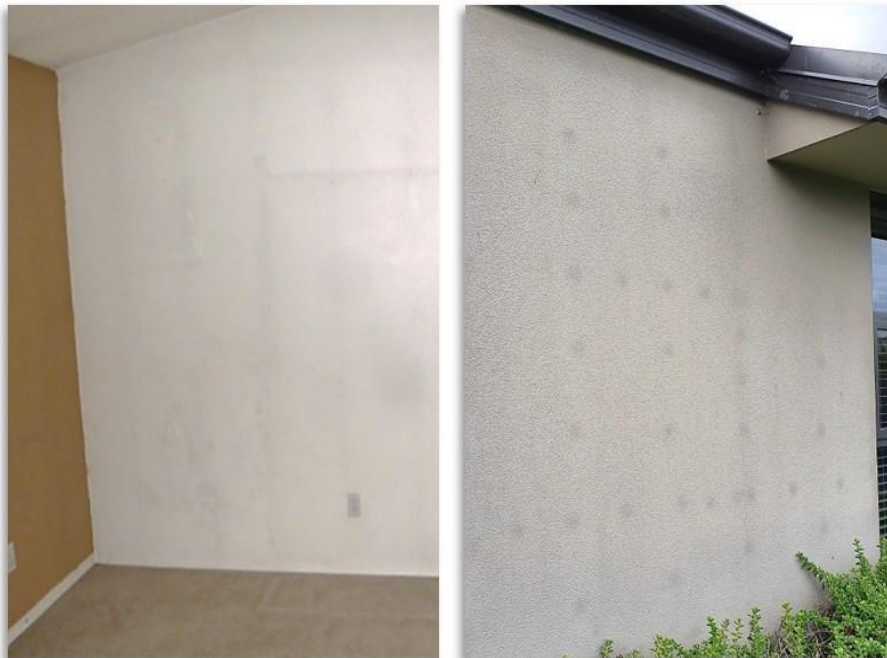
Description: Darker areas / spots showing up on the surface following the framing lines behind. Above Left photo, wall framing showing up and Right photo, fixing head areas showing through the polystyrene cladding.

Probable Cause/s: Ghosting (thermal bridging) is caused by either the frame work or fixings (nails/screws) being colder the surrounding surface due to a heat sink affect. The immediate underlying area is less insulated compared to the area directly next to it. This can cause damp air to condense on the colder area (above frames/fixing heads) that are colder. The result being darker areas that follow the patterns of the framing. As you can see above, you can see the heads of the fixings in the polystyrene sheets under the plaster which, because they are metal, are even colder and more prone to becoming a condensing surface. This is seen on exterior cladding just as much as interior linings. Typically, the condensation can cause more dirt's to adhere to the surface and more surface moisture, causing a colour change, thus creating irritating lines or spots on the surface.

Prevention: Follow correct building / cladding and fixing guide lines. To reduce ghosting on inside surfaces, eliminate indoor air particulates e.g. stop burning candles, coal/firewood or incense and control relative humidity (inside) to maintain below 60 % during the colder months of the year.

Remedy: If staining is developing in larger patterns this indicates the wall or ceiling may not be insulated correctly or the fixings need to be insulated with special insulation plugs. The repair in any case will require that the wall or ceiling is opened-up and insulated in a better way using certified builders/plasters who understand the issue.
