# Dealing with older existing weatherboards and broadwall areas

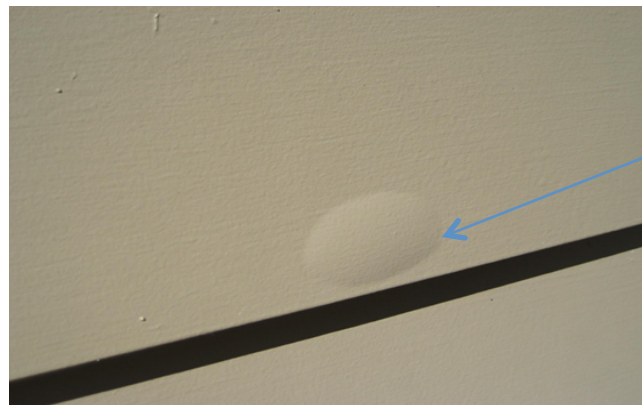
At MPNZA our attention is being drawn, on a regular basis, to failing paint coatings on freshly painted existing weatherboards. We are seeing weatherboards, which when prepared for repainting, the paint coating appears sound. Shortly after completion of the repainting, blistering and peeling are evident. This peeling and blistering goes back through many coats to the original primers when the weatherboard was first painted, often many years before.

The advent of modern acrylic coating systems, with their ability to expand and contract with temperature, places massive tension on previous coats. These previous coats are often many years old and were never intended to last the 30 plus years they have sat on the weatherboard and broadwall areas. The constant expansion and contraction of the new coating results in these older existing coatings delaminating. The use of darker colours exacerbates this tremendously due to the increased heat absorbed by the darker paint coating causing movement in the timber as well as the new paint coating. Also remember that old enamel paint is impervious and will not allow the transfer of vapour to outside of the house, as acrylics will. Thus moisture will build up behind old enamel and also cause the blister, if the enamel is already weakened by the new acrylics applied over the years, bubbling will be worse. Paint manufacturers are able to place greater and greater guarantees on the longevity of their exterior broadwall products because of the flexibility of these modern coating systems. When a paint manufacturer can place a 15 year guarantee on the paint product it is probably not unreasonable for the consumer to expect the paint job to last this long.

Typical blistering when delamination of older paint coats under new paint coating occurs.

Master Painters NZ Association recommends that consideration be given to removing all existing paint coatings from timber weatherboards and any other broadwall surfaces to be repainted that are **older than 25 years**. While this will increase the cost of repainting to the consumer, failure to remove the existing coating is likely to result in the failure of the new coating with costly ramifications for the painting contractor. It is highly recommended the attention of the consumer should be drawn to this likely problem during the quotation and assessment of the work to be carried out and before any repainting takes place. Testing for lead based coats should be carried out prior to the removal of the paint coating.
