Common Paint Problems: Efflorescence

What is Efflorescence? Efflorescence appears as a white deposit of mineral salts on face of concrete walls and/or floors. Efflorescence usually appears in underground car park areas and other subfloor areas. Efflorescence is caused by moisture ingress. As the moisture enters and moves through the wall or floor, it dissolves mineral salts present in the cement. This mineral salt solution eventually finds its way to the surface of the concrete. As the water evaporates, it leaves behind a white deposit of mineral salts on the surface.

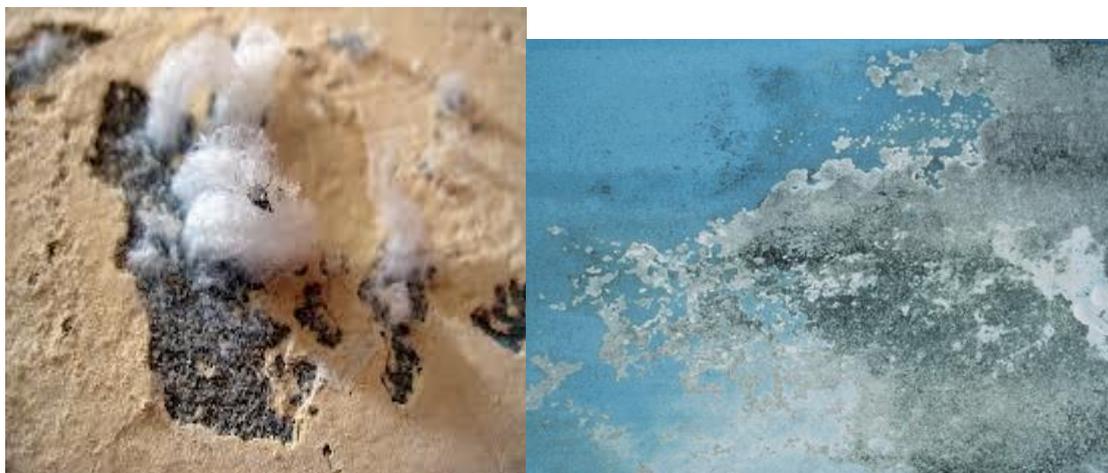
Even if all the efflorescence is thoroughly removed, moisture will still be present in the concrete. Where there is moisture in concrete, there is hydrostatic pressure. Hydrostatic pressure will force the moisture out of the concrete and collect between surface of the concrete and the coating system, forming blisters under the coating and causing the coating to delaminate.

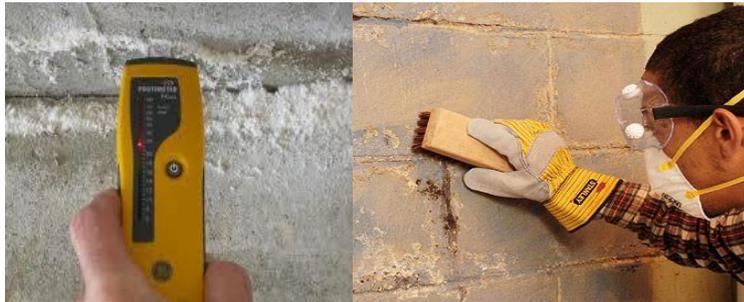
1. Ensure that the concrete has been cured for at least 30 days.
2. Remove all efflorescence, other surface contaminants and loose material. Any one of a number of techniques may be used, including, but not limited to, wire brushing (hand or power tool), dry abrasive blasting or high-pressure water jet. (The use of water will reintroduce some moisture into the concrete and can cause some reappearance of efflorescence. Allow concrete to dry, and wire brush any residual efflorescence.) Check for any reoccurring efflorescence, as this may indicate a leakage problem.
3. Check moisture content of concrete. This should be <10%, as measured with a standard moisture meter. If so, the concrete is ready to coat. If not, go to step 4.
