# Common Paint Problems:

## Picture Framing

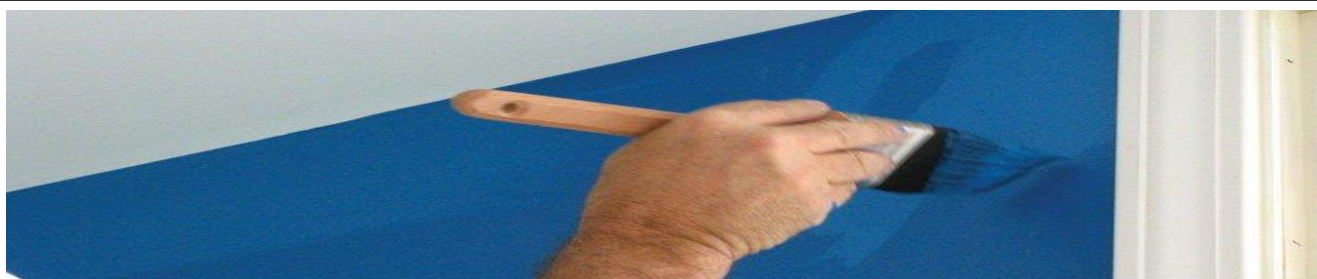
A non-uniform appearance of colour that occurs when a wall is painted with a roller and the edges (where the roller could not reach) are "cut in" with a brush. The brushed areas generally appear darker, thus resembling the frame of a picture. Sprayed areas may be darker than neighbouring sections that are brushed or rolled.

- Applying paint at different film builds (e.g. thickness of each coating layer) as a result of using a thick brush cut-in application versus a thin roller application. Spraying versus brushing may also show the problem because of differing film builds.
- Not keeping a wet edge while painting (i.e. applying wet paint to the edge of dry or almost dry paint).
- Incomplete mixing of the paint; material that has settled to the bottom is not uniformly incorporated.

- Don't cut in the entire room before painting the larger areas. Work in smaller sections of the room to maintain a wet edge. When using a brush, only cut in as narrow an area as needed, usually 20mm – 40mm, using the roller as close to the corner as possible.
- Apply the coating as uniformly as possible with any application method.
- All colours, including white, should be thoroughly shaken before use.
